PHASE I ENVIRONMENTAL SITE ASSESSMENT

Treacchar Parcel
North Pima Road and Frank Lloyd Wright Boulevard
Scottsdale, Arizona 85260

August 28, 2012

**Subject: Report of Phase I Environmental Site Assessment, Treacchar Parcel
North Pima Road and Frank Lloyd Wright Boulevard
Scottsdale, Arizona 85260
GES Project No. 3200337**

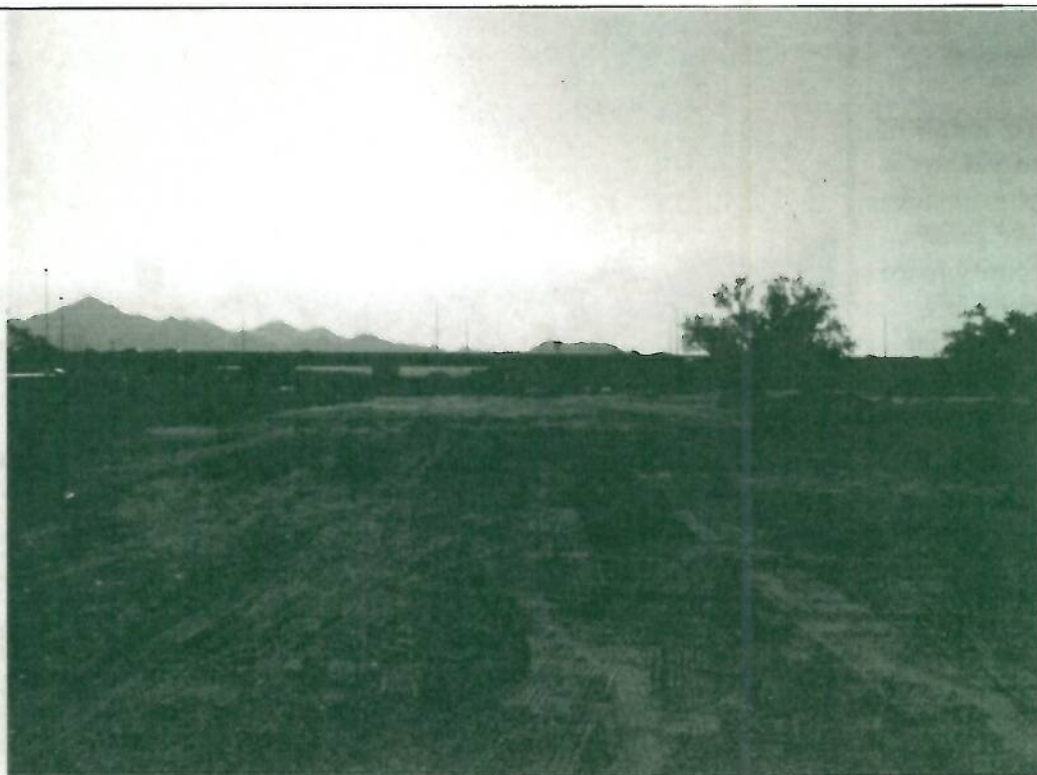
Photo 3:

The west end of the Site, from the west end of the Site. Frank Lloyd Wright Blvd. on the right, CAP canal security fence on the left.

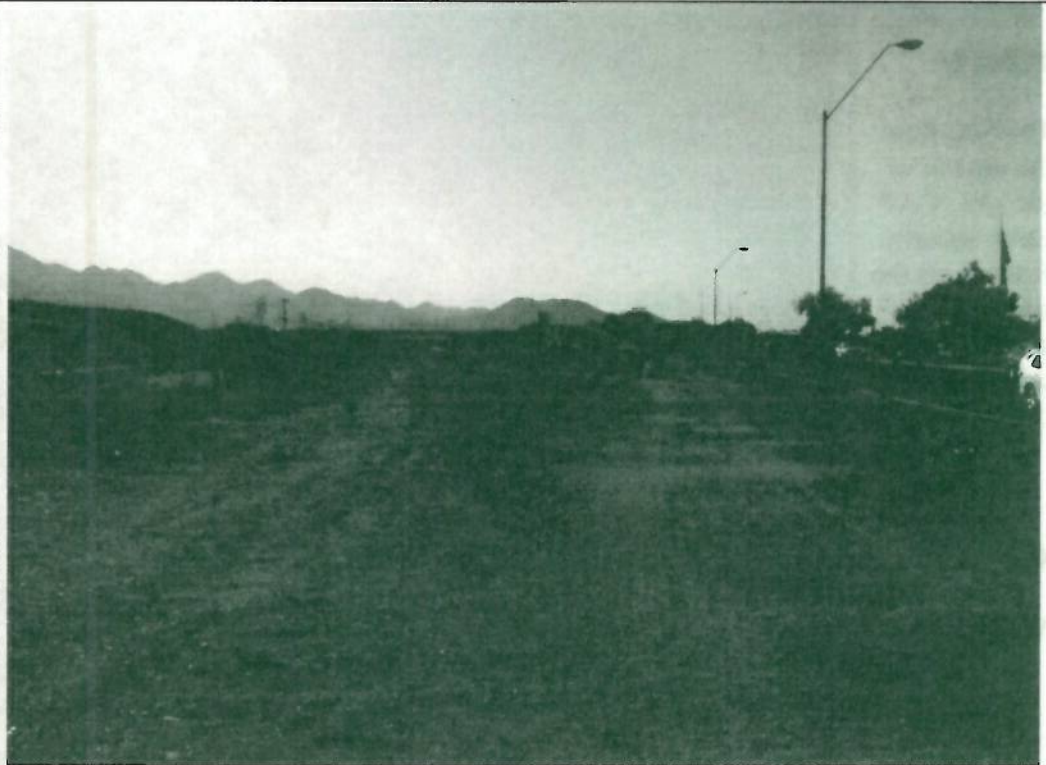
Photo 4:

The middle of the Site from the west side. CAP canal security fence on the left, commercial development on the right.

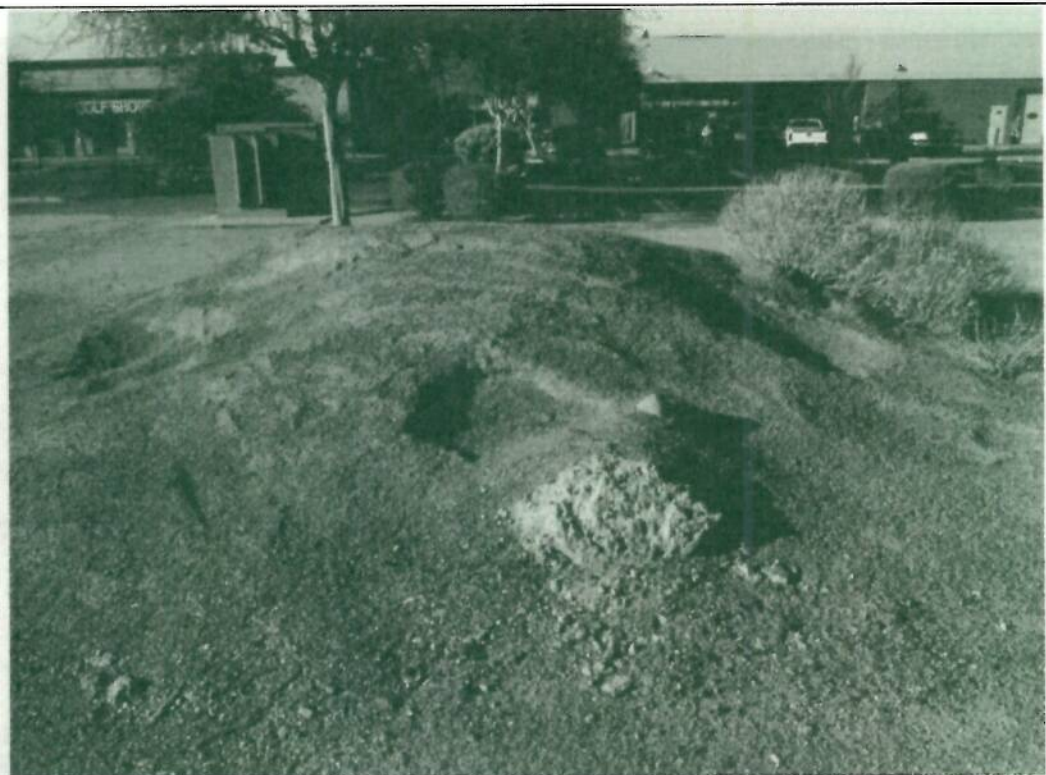
Photo 6:

Large pile of
fill dirt in the
middle of the
site.
Transformer
in the
background
on Site.

Electrical transformers are a potential recognized environmental condition due to the potential presence of polychlorinated biphenyls (PCBs) contained in dielectric fluids used in some units. GES observed one pad-mounted transformer along the southern boundary of the Site. The transformer appeared to be in good condition with no staining or evidence of leaking.

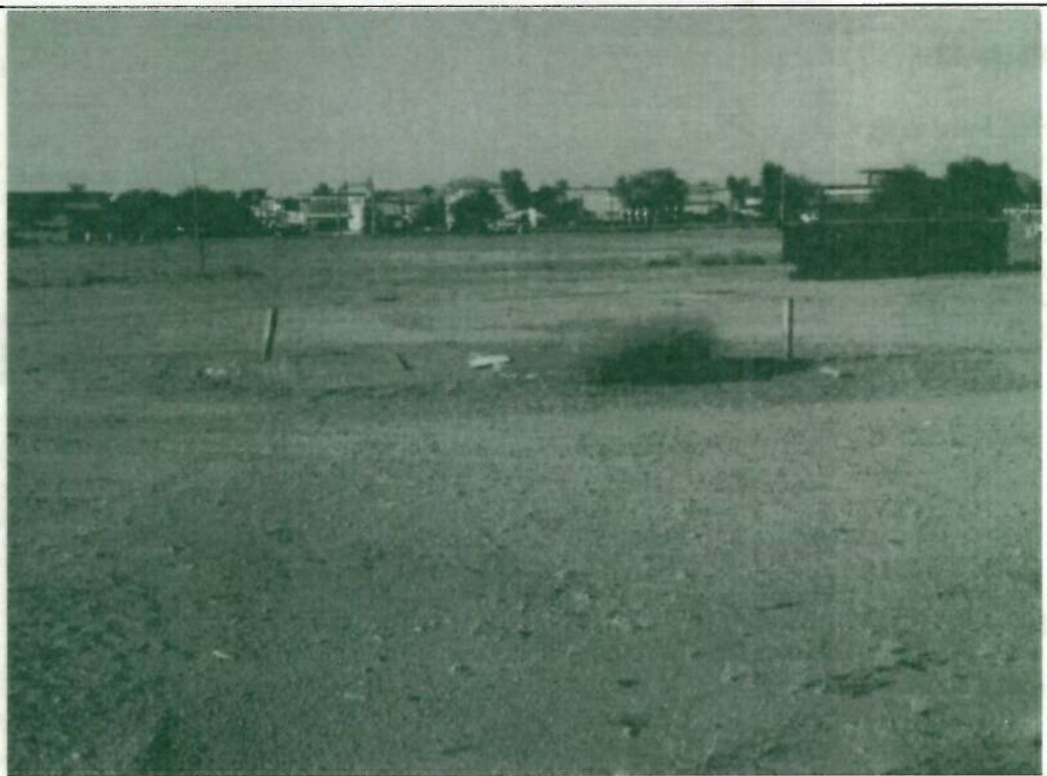
Photo 10:

Site, east of construction. Dumpster associated with construction project. Small line of vegetation beyond dumpster marks Site's southern border.

One roll-off dumpster was observed at the east end of the Site near the construction project. At the time of the Site reconnaissance the dumpster was empty however; its presence indicates the intent to store waste on the premises. GES did not observe any other solid waste disposal at the Site.

No hazardous substances or petroleum products were observed being stored at the Site at the time of the Site reconnaissance. There was a small construction project underway at the time of the Site visit at the eastern end of the property. The construction project appeared to be improving/adding pipelines across the CAP canal. No RECs or *de minimis* conditions were observed to be associated with the construction project. In addition three large subsurface vaults were observed on the east end of the Site and presumably house CAP canal infrastructure. A small pile of fill dirt, not associated with the CAP construction project, was also observed along the middle of the southern edge of the Site, no staining or odors were apparent on the soil at the time of the reconnaissance. GES recommends removal of the waste disposal roll-off bin so that waste does not accumulate on Site.

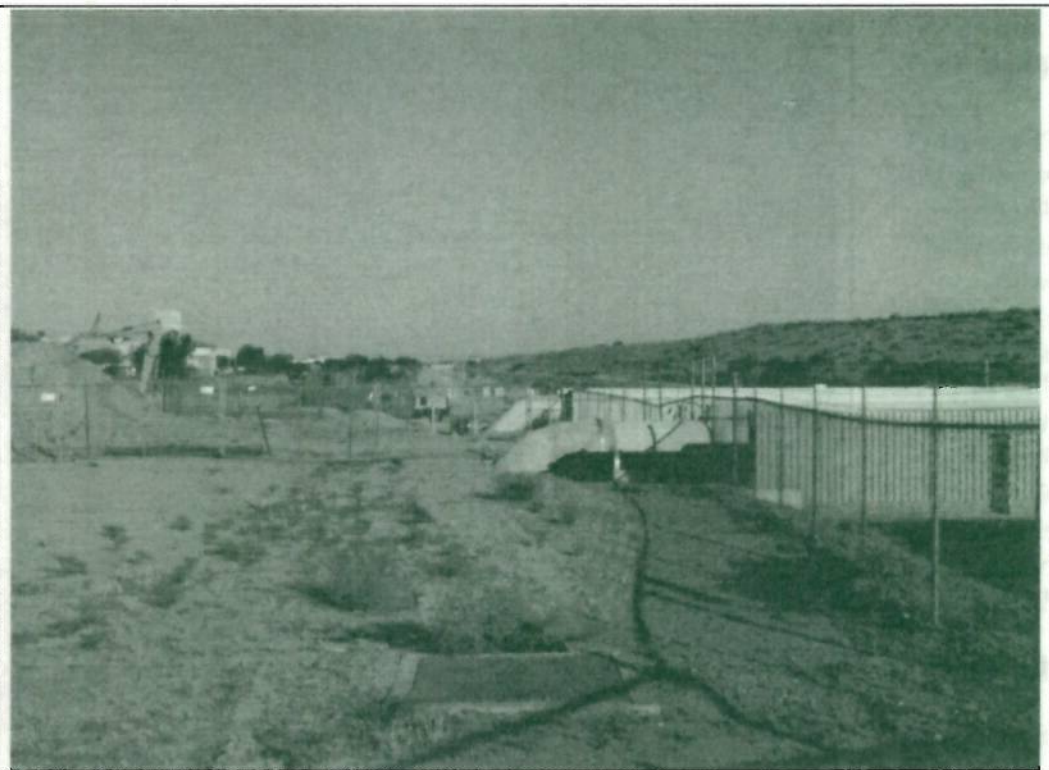
Photo 12:

Site from east end, looking through the construction project to more of the Site beyond.

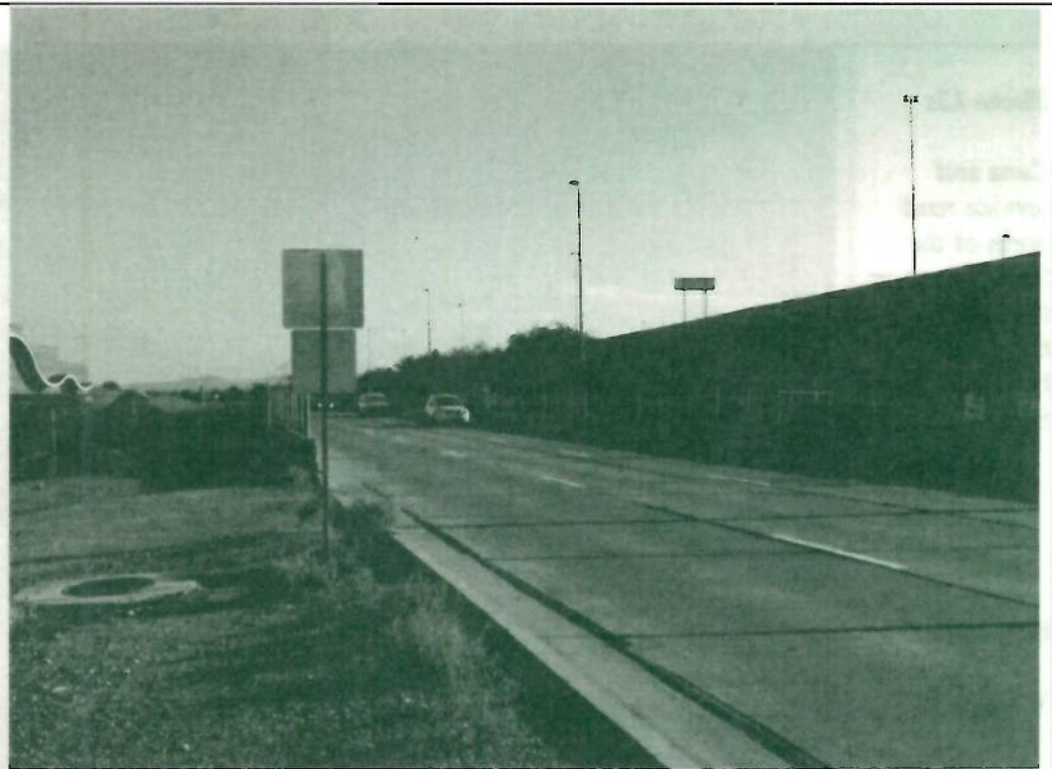
Photo 15:

N Pima Rd, pavement marks the eastern border of the Site. Scottsdale sanitary sewer manhole cover on the left on-Site, overpass on left is State Route 101.
